Fairmont mine pool flooding

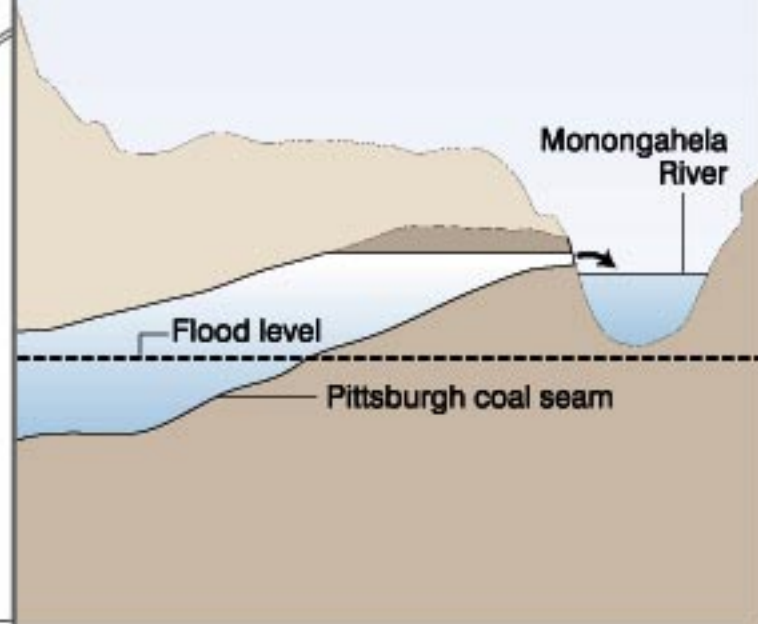
Hundreds of abandoned mines along the Monongahela River, from northern West Virginia into southwestern Pennsylvania, are flooded or filling with ground water and surface water runoff. The water in interconnected mines forms what is known as a mine pool. Untreated discharges from those pools could soon threaten the water quality of the river and its tributaries. If mining companies stop treating the discharges, West Virginia and Pennsylvania may have to cover millions of dollars in treatment costs. Two points likely to begin discharging soon are at the Clyde and Shannopin mines in Greene County.

The Pittsburgh coal seam has been mined for over 100 years and many smaller mines have closed and stopped pumping out and treating acid mine water. When the mines flood to the level of nearby rivers or creeks the untreated water can discharge into those bodies of water.
